Safety Inspection Report

Annual Inspection

Playground at Berristead Close

19 April 2024

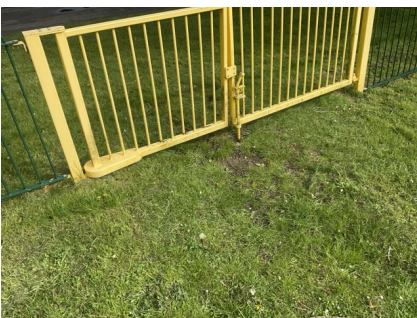
Ground erosion present.

Consider adding grass matting to prevent wear.

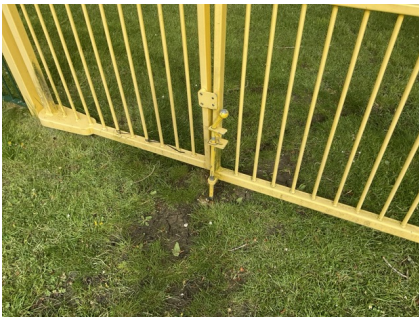
The item is unlocked.

Lock.

Clean out drop bolt sleeve and provide a padlock for the maintenance leaf.

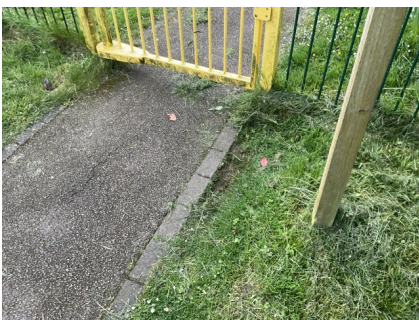
Trip points on the surface.

Build up surface level to remove trip points.

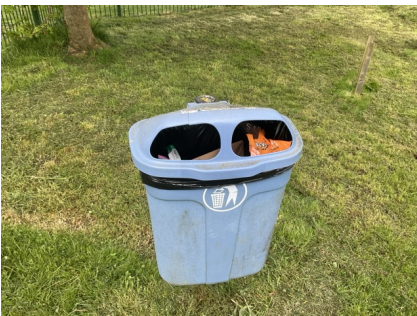
Bin is full.

Empty the bin.

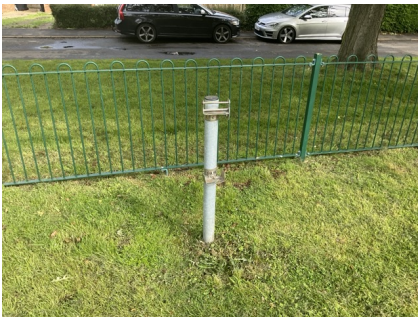
Item is damaged.

Replace missing bin or remove post.

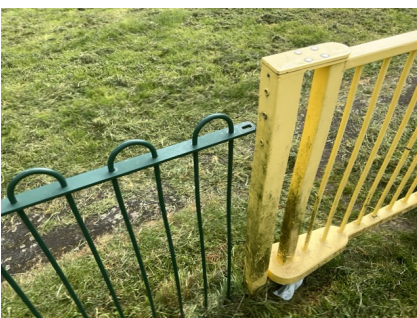
Fixtures loose or missing.

Replace missing fence bracket.

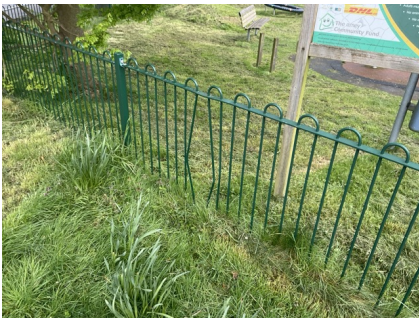
Item is bent.

Repair.

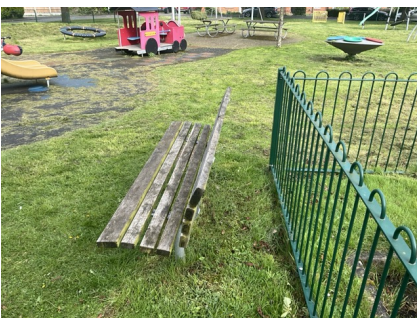
RoSPA recommend a minimum distance of 1 m between seat and fence. This is to reduce the likelihood of children vaulting the fence via the seat.

No reasonably practicable action is identified.

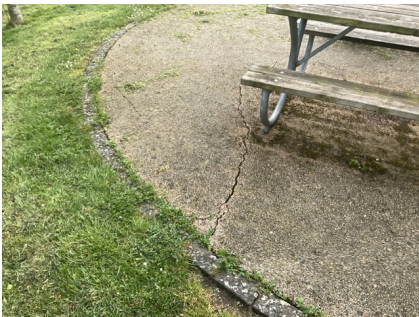
The surface is cracking.

Monitor and repair as required.

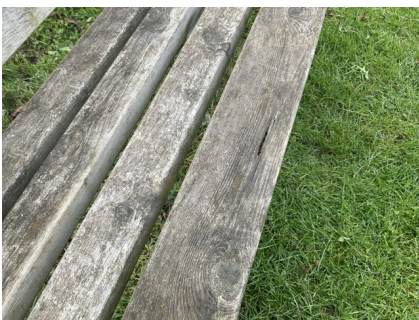
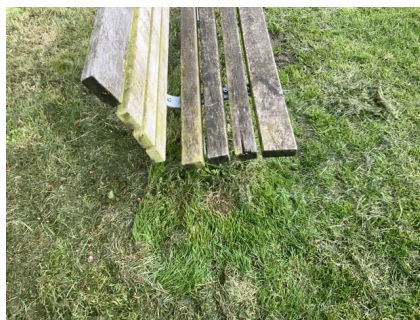
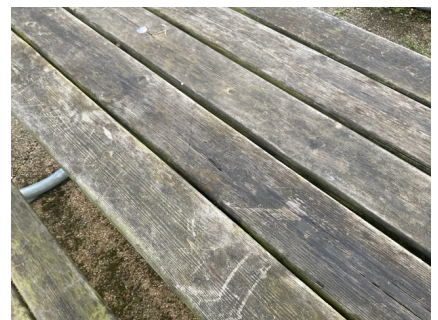
Timber is decayed.

Check on a routine basis.

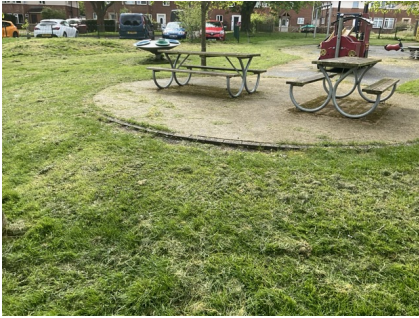
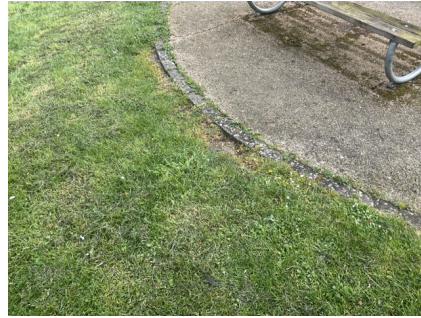
Trip points on the surface.

Build up surface level to remove trip points.

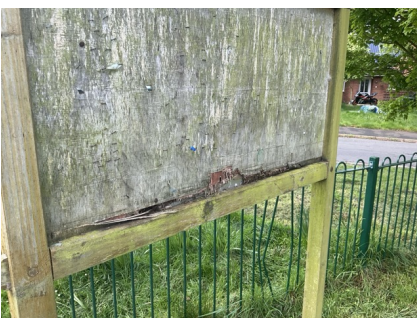
Timber is decayed.

Backboard rotting/splintering.

Check on a routine basis.

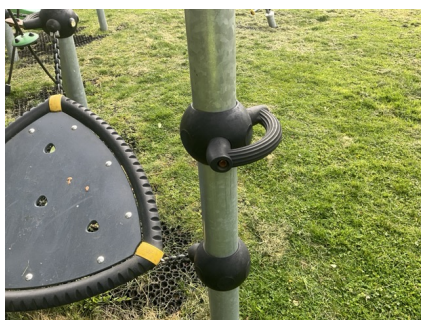
Cap missing.

Replace.

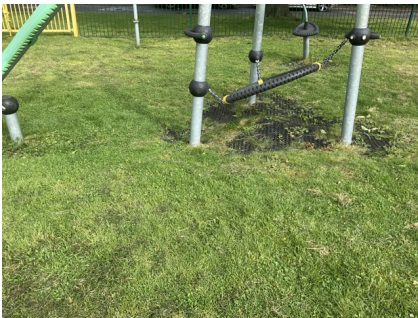
Surface is uneven.

Make good.

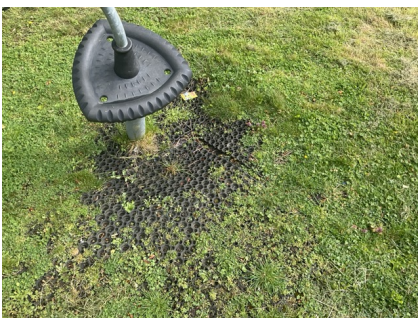
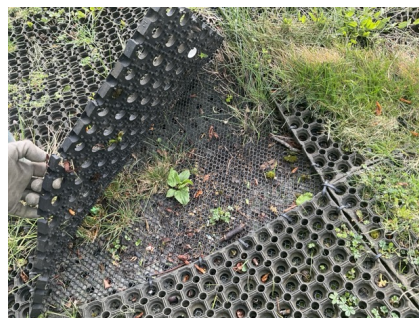
The surface is damaged.

Mats separating and loose. Secure.

Repair.

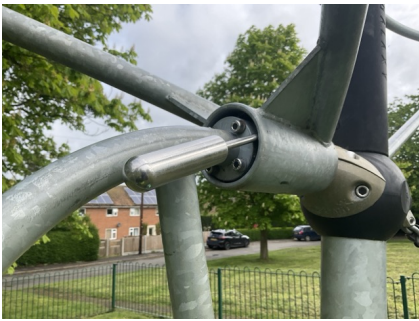
Finger entrapment.

Eliminate the entrapment.

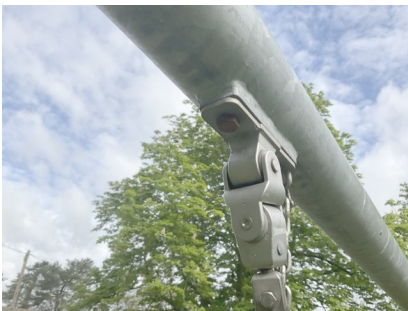
There is wear in the bushes.

Top bushes wearing. Monitor.

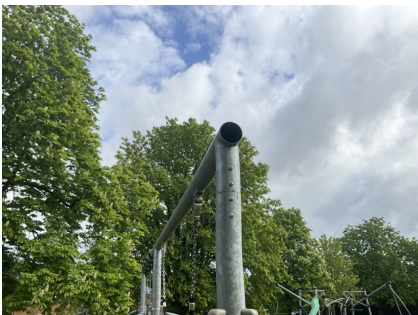
Cap missing.

Crossbar cap x 1 missing. Replace.

Replace.

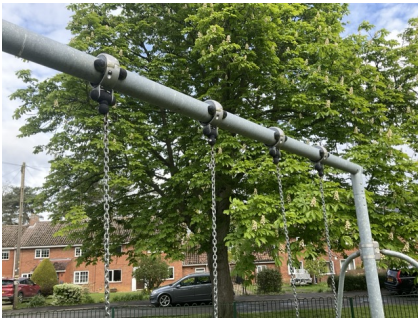
The covers should be removed from the fitting at the top of the chain annually and the shackle bolt should be checked for wear. Check the security of the fittings too.

Replace at 70% of original diameter (30% wear).

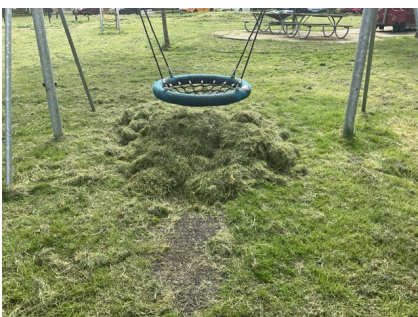
Additional comments are noted below.

Remove grass clippings from site.

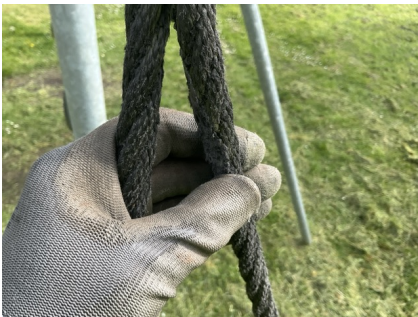
Exposed metal rope core(s).

Monitor for any sharp or split wire strands.

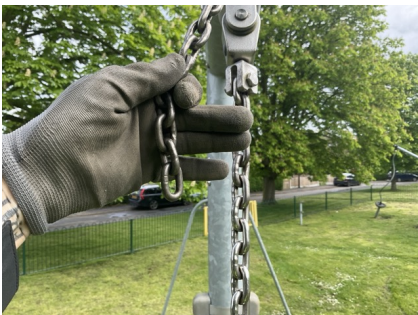
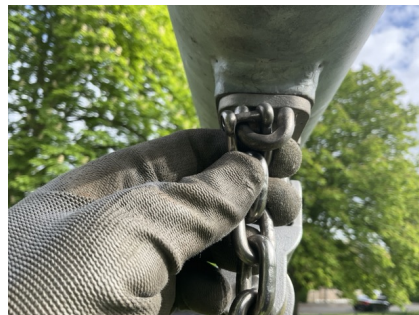
Swing D-shackles are worn.

Secondary shackle missing x 1 and shackle x 1 worn. Replace.

Replace.

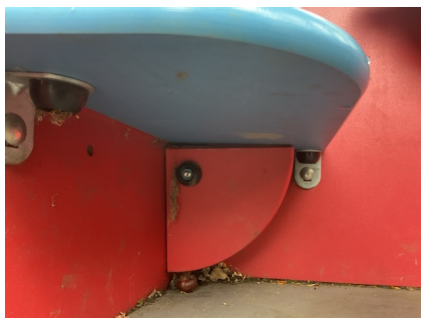
Cap missing.

Replace.

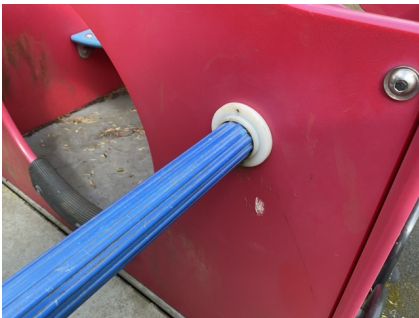
Fixtures loose or missing.

Replace.

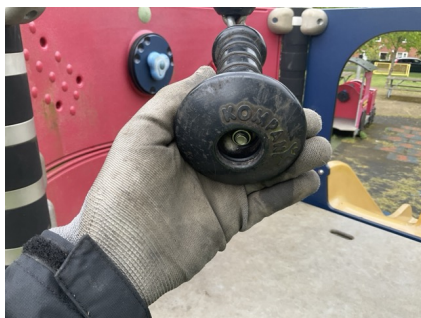
Cap missing.

Replace.

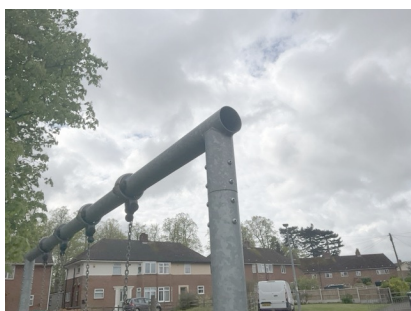
Cap missing.

Replace.

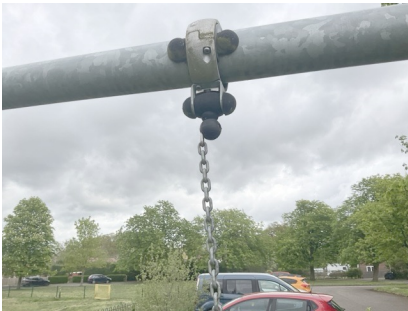
The covers should be removed from the fitting at the top of the chain annually and the shackle bolt should be checked for wear. Check the security of the fittings too.

Replace at 70% of original diameter (30% wear).
