Safety Inspection Report

Annual Inspection

Playground at Berristead Close

19 April 2024

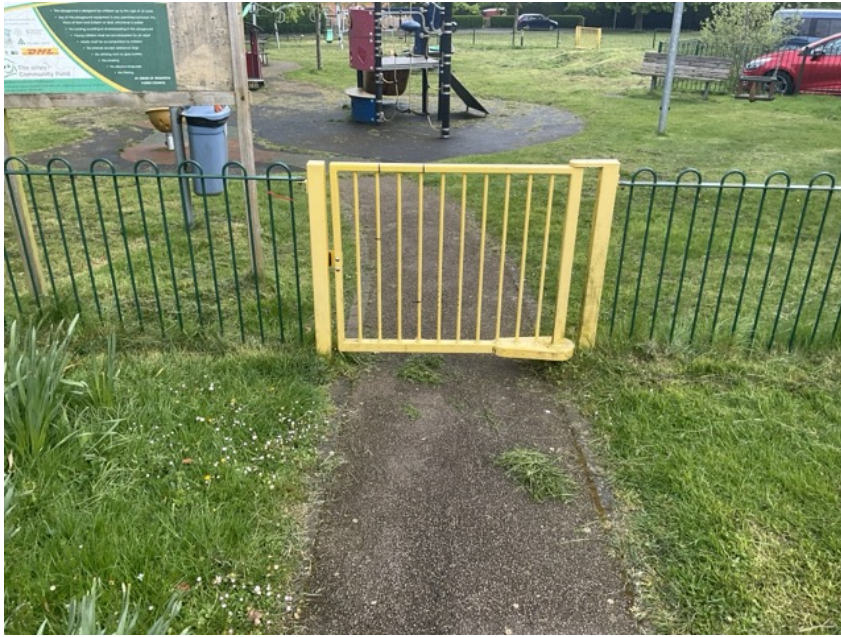
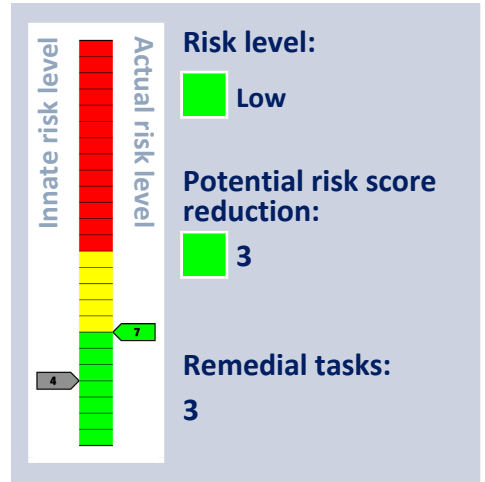
Gates

6
Ground erosion present.	Consider adding grass matting to prevent wear.

Consider adding grass matting to prevent wear.

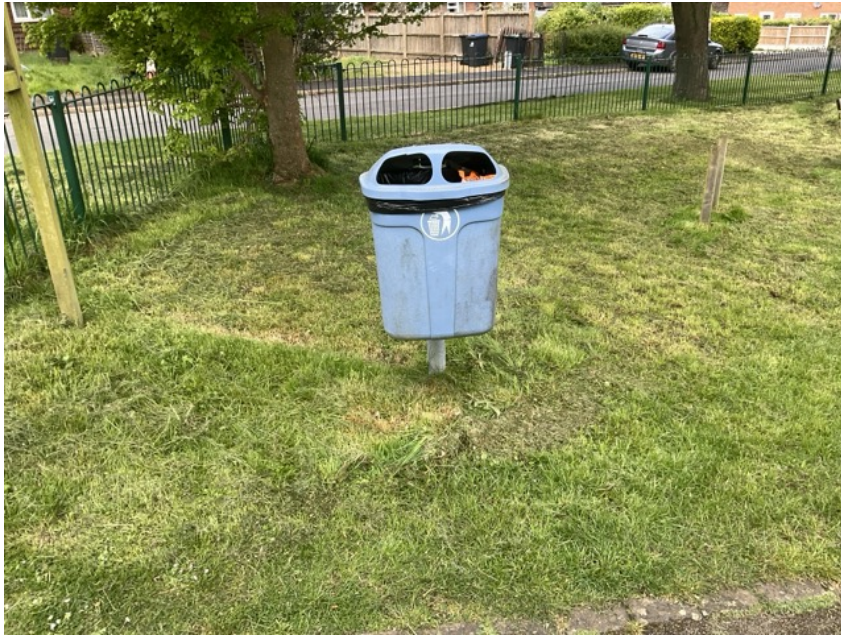
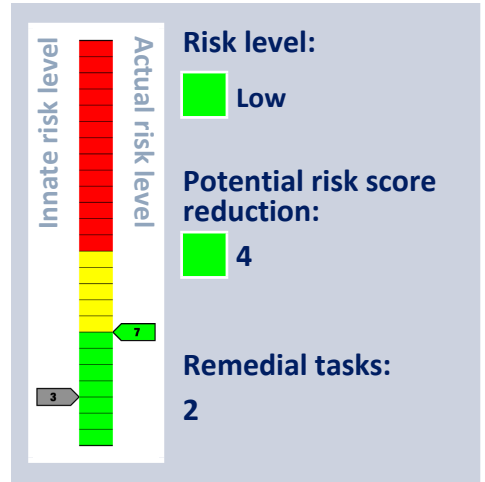
Litter Bins

Item is damaged.

Replace missing bin or remove post.

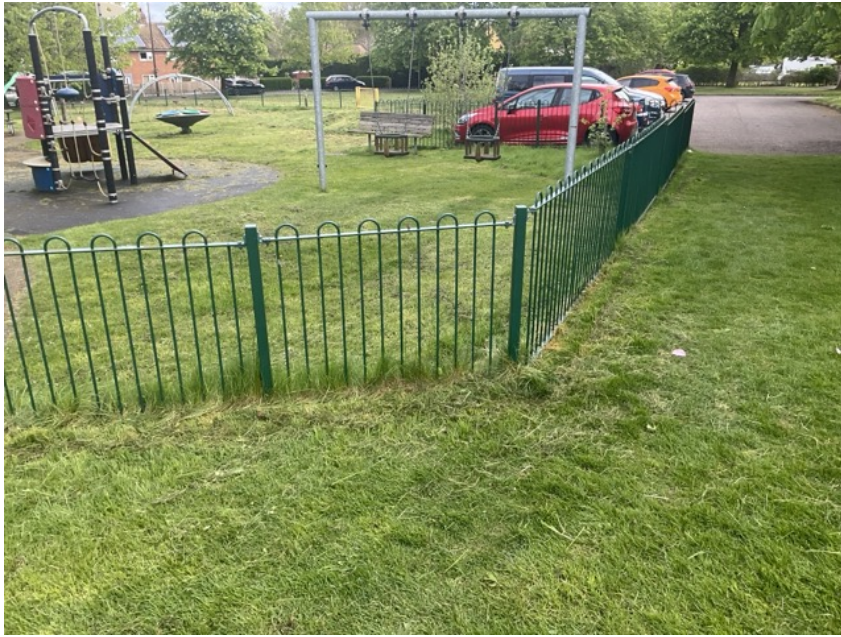
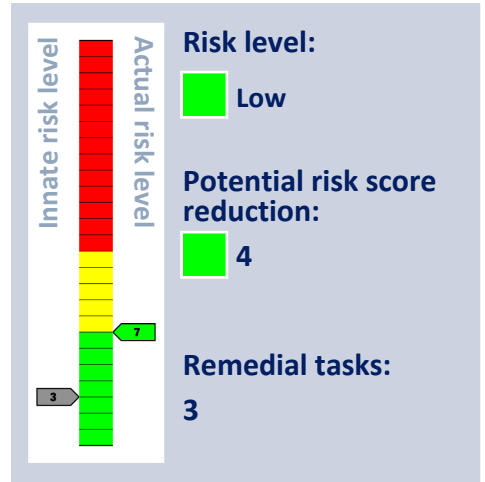
Fencing - Bow-Top

Fixtures loose or missing.

Replace., Read the notes for further action.

Replace missing fence bracket.

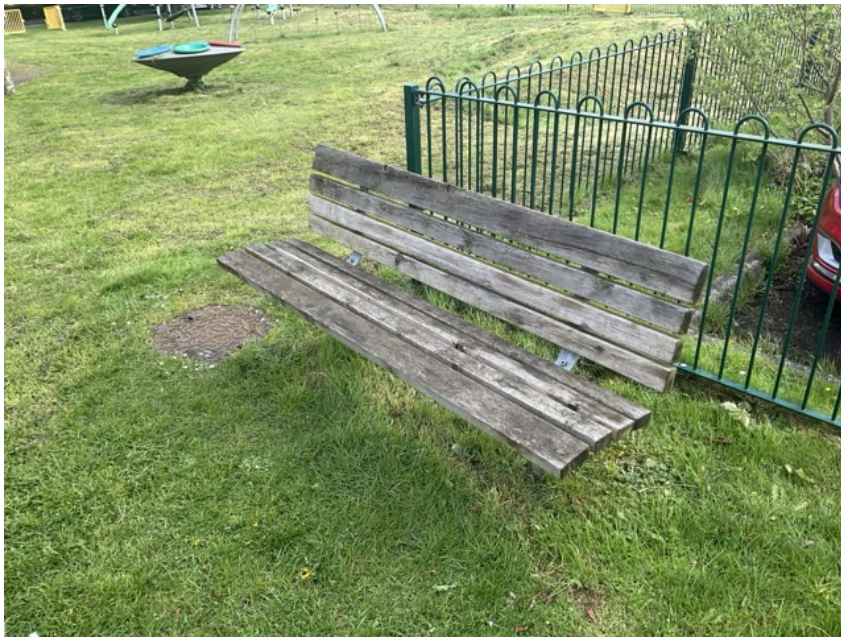
Seating - Various

RoSPA recommend a minimum distance of 1 m between seat and fence. This is to reduce the likelihood of children vaulting the fence via the seat.

The surface is cracking.

Monitor and repair as required.

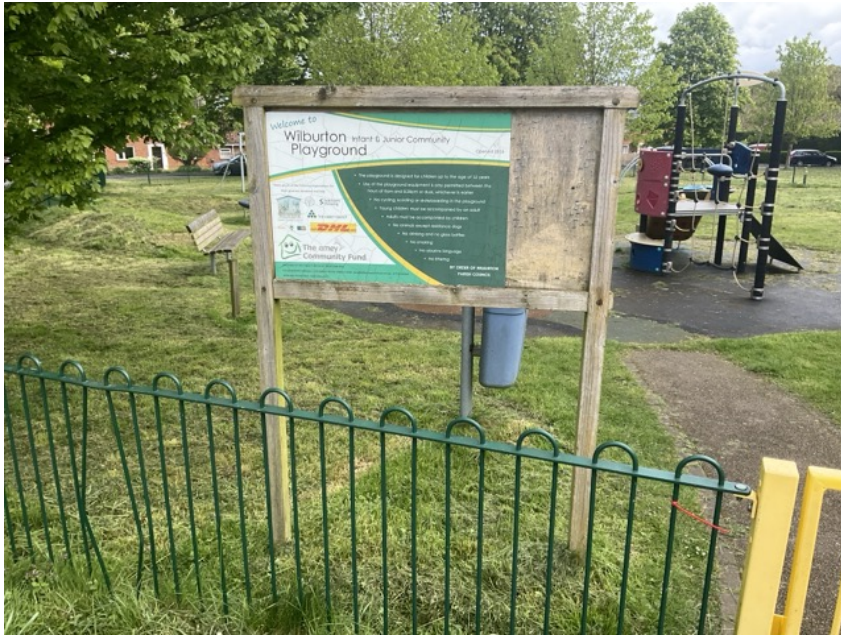
Signage - Ownership

Timber is decayed.

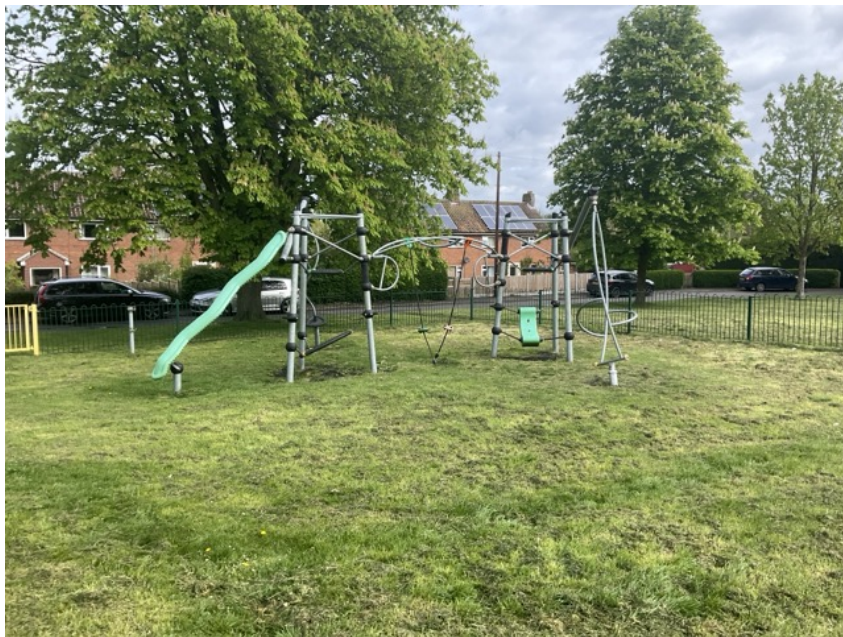
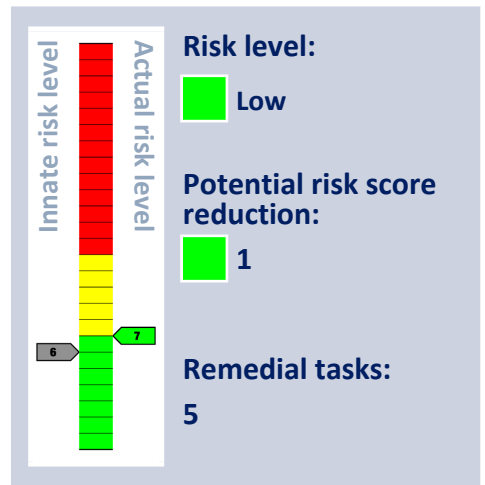
Multiplay - Climber

Cap missing.

The surface is damaged.

Mats separating and loose. Secure.

This item is associated with accidents. In RoSPA's opinion, this item may fail the requirements of EN 1176 (4.2.1) in that the movement of the blue climber on this unit is not apparent and foreseeable and could be considered to present a hazard to the user.

Replace.

Repair.

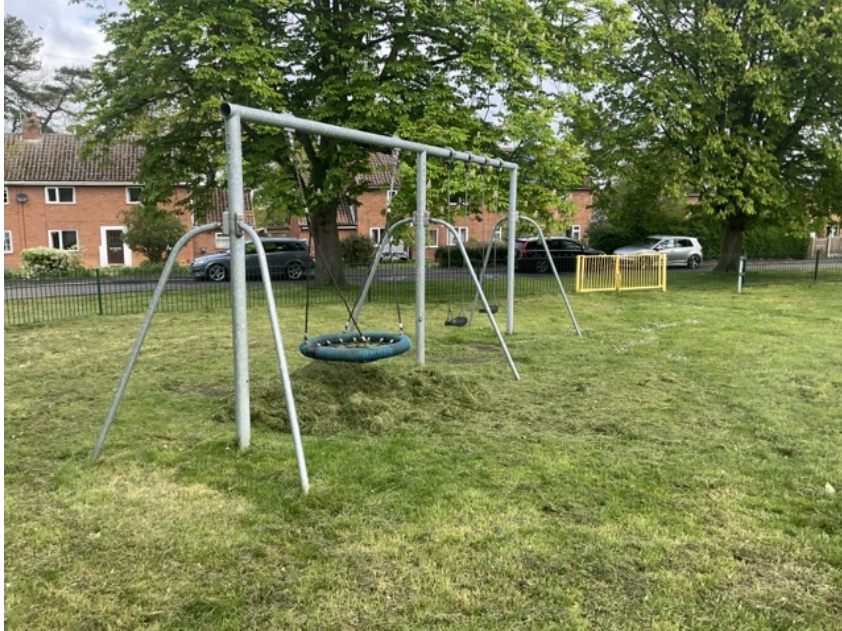
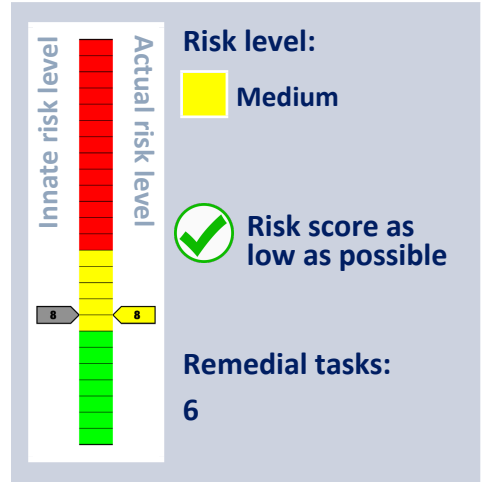
Swing - Mixed - 2 Bay 1 Basket 2 Junior Seat (2600 mm)

There is wear in the bushes.

Top bushes wearing. Monitor.

Cap missing.

Crossbar cap x 1 missing. Replace.

Swing D-shackles are worn.

Secondary shackle missing x 1 and shackle x 1 worn. Replace.

Replace.

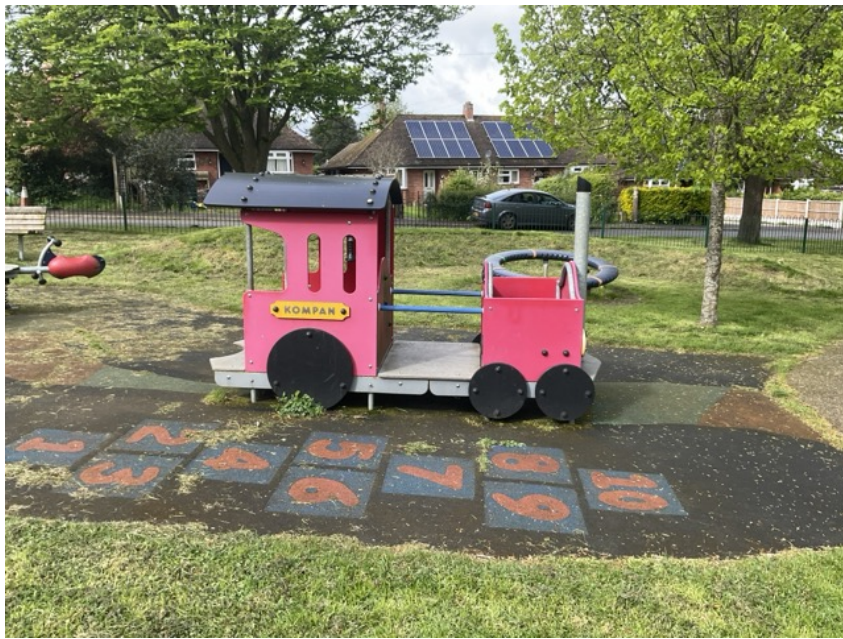
Play Train

Cap missing.

Fixtures loose or missing.

Replace.

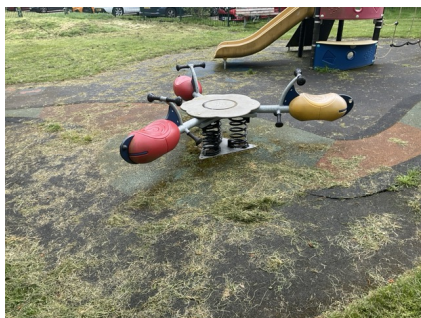
7
The wet pour surface is separating at the joints.	Re-glue and fill gaps and joints as necessary., Repair.

Re-glue and fill gaps and joints as necessary., Repair.

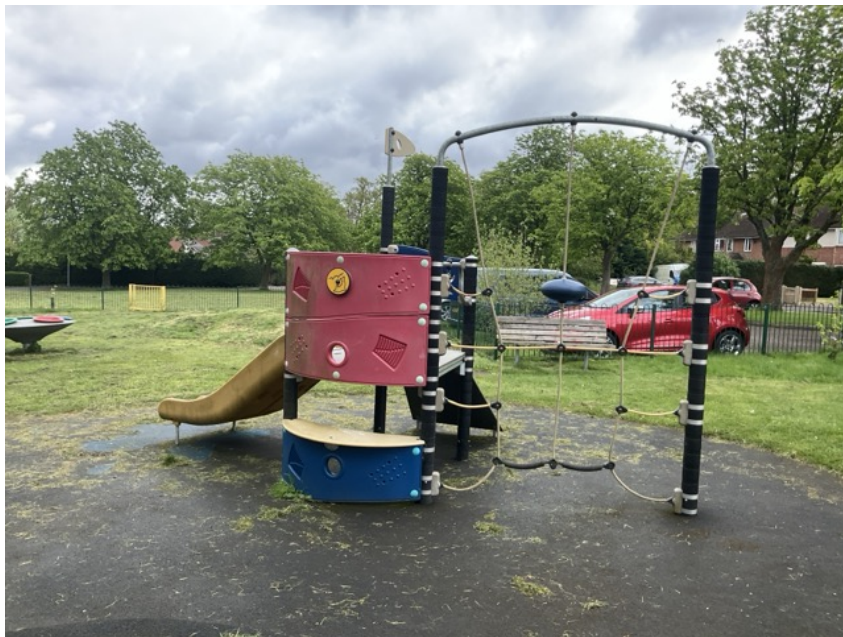
Multiplay - Junior

Cap missing.

Replace.

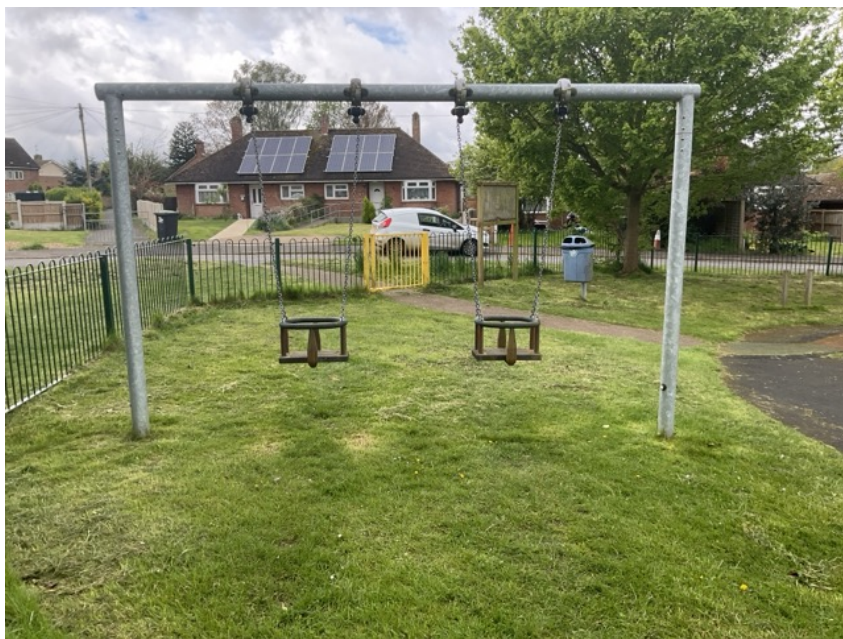
Swing - Toddler - 1 Bay 2 Seat (2100 mm)

Cap missing.

The covers should be removed from the fitting at the top of the chain annually and the shackle bolt should be checked for wear. Check the security of the fittings too.

Replace.

Replace at 70% of original diameter (30% wear).
